River Raisin Area of Concern Sterling Island Restoration

City of Monroe
Monroe, Michigan

ECT Environmental
Consulting &
Technology, Inc.

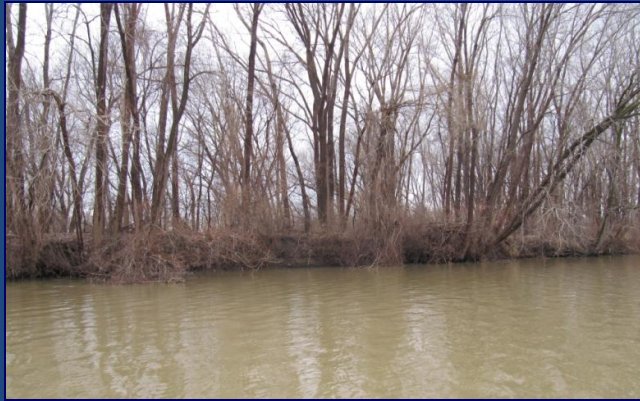
- Sterling Island has experienced significant erosion.
- The island was identified as being a contributor of sediment that has impaired aquatic habitat downstream.
- Restoration of Sterling Island was specifically listed as a project required for removal of the Degradation of Fish and Wildlife Populations and Loss of Fish and Wildlife Habitat BUIs in the River Raisin AOC.

- Island is wooded
- Tops of banks are vegetated.
- Severe bank undercutting (up to 5-feet deep)
- Flow measurements and calculations were conducted. River flow velocity was found to be relatively low.
- Erosion is not due to energy associated with river flow. Rather, the erosion is caused by wave action and ice scour.

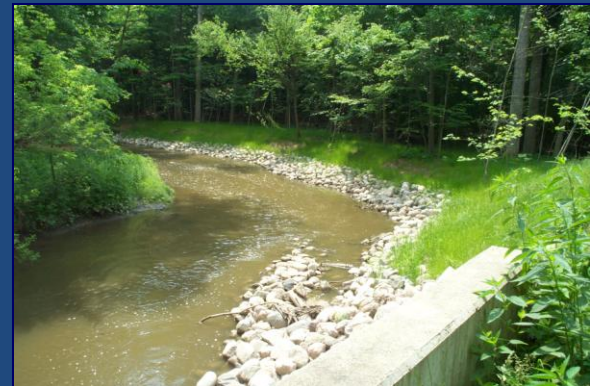
Proposed Project

Rock Vane

Re-grading
and Timber
Stairs

Longitudinal
Stone Toe

Longitudinal
Stone Toe
Tie- Back

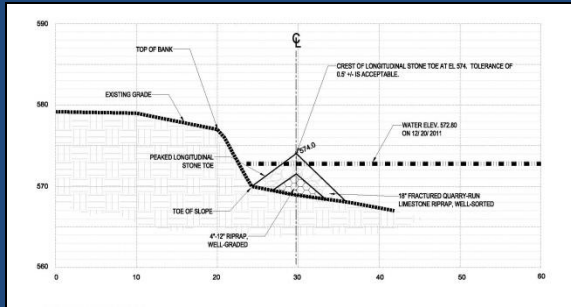
Longitudinal Stone Toe

- Protects eroded banks
- Promotes vegetation establishment
- Minimal disturbance
- Provides habitat
